WT-1631

PROVIDE TO EXISTING EPG STRUCTURES (U)

Release Date: October 27, 1964

(6) DAMAGE to EXISTING EPG STRUCTURES (U)

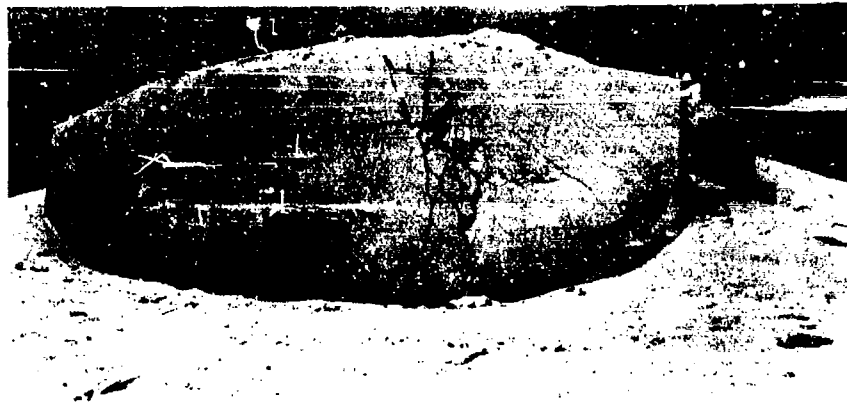
Figure 4.9 Post-Koa, (Item 19) Station 1525, face-on view.
Pressure level: Koa, 42 psi; 350 cal/cm^2 .

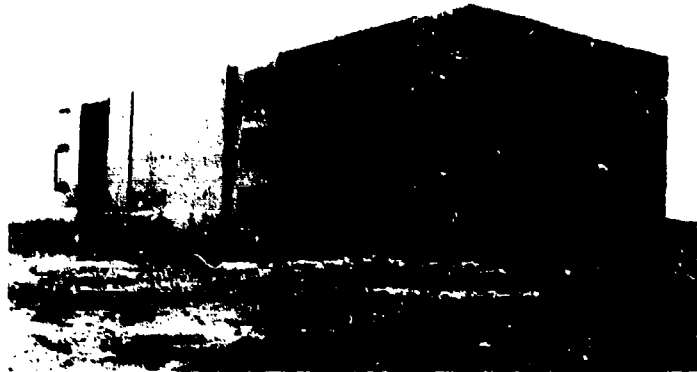
Figure 4.40 Post-Walnut, (Item 26) Station 3.1.1. Pressure level: Walnut, 16 psi.

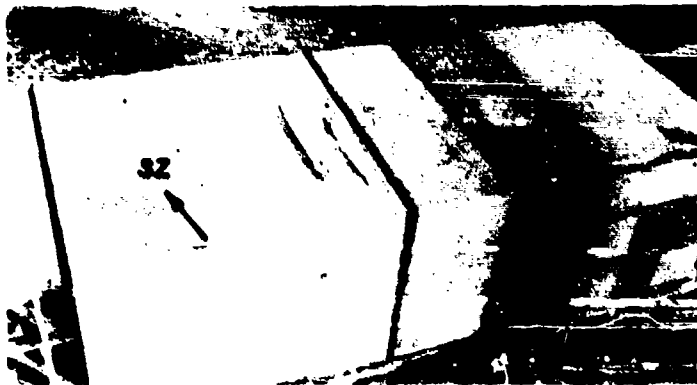
Figure 4.41 Post-Walnut, (Item 26) Station 3.1.1, aerial view. Pressure level: Walnut, 16 psi.

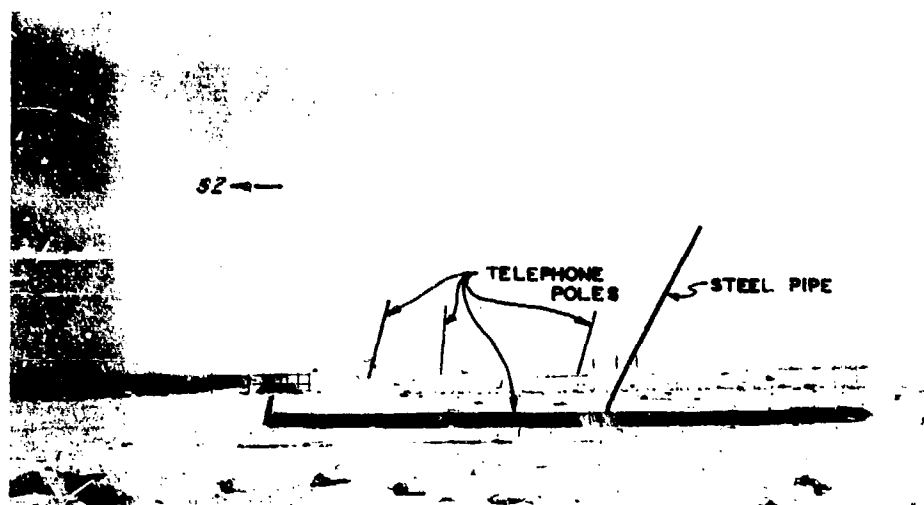
Figure 4.101 Post-Butternut, telephone poles. Pressure level: Butternut, 12 psi.
